Maryland Inventory of Historic Properties

MIHP Number: CAR-357

Property Name: Denton Shirt Factory

**MARYLAND HISTORICAL TRUST
DETERMINATION OF ELIGIBILITY FORM**

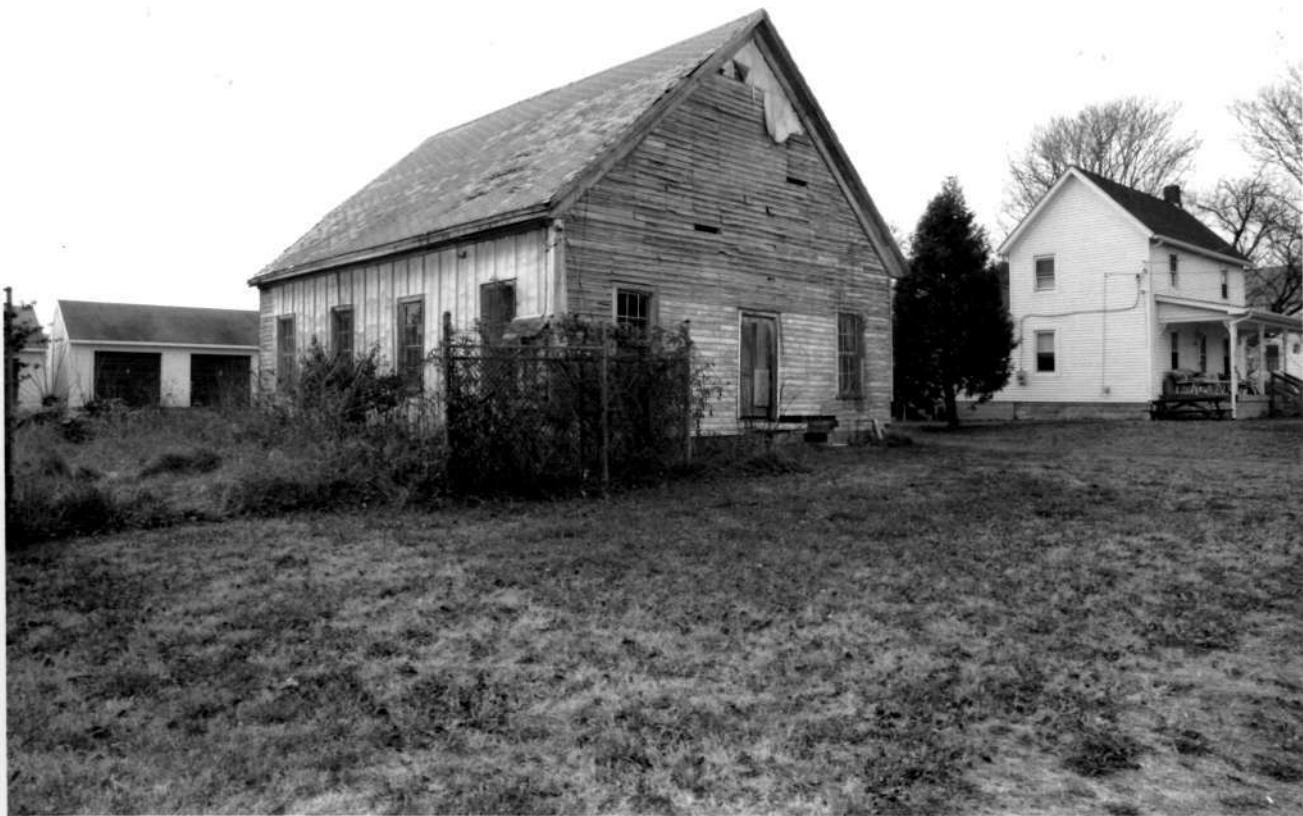
1 of 5

Description Photograph #1- North elevation view of W. Denton Sewing Factory with partial east elevation. Photo take from the northeast facing southwest from Steamboat Alley (unpaved public road).

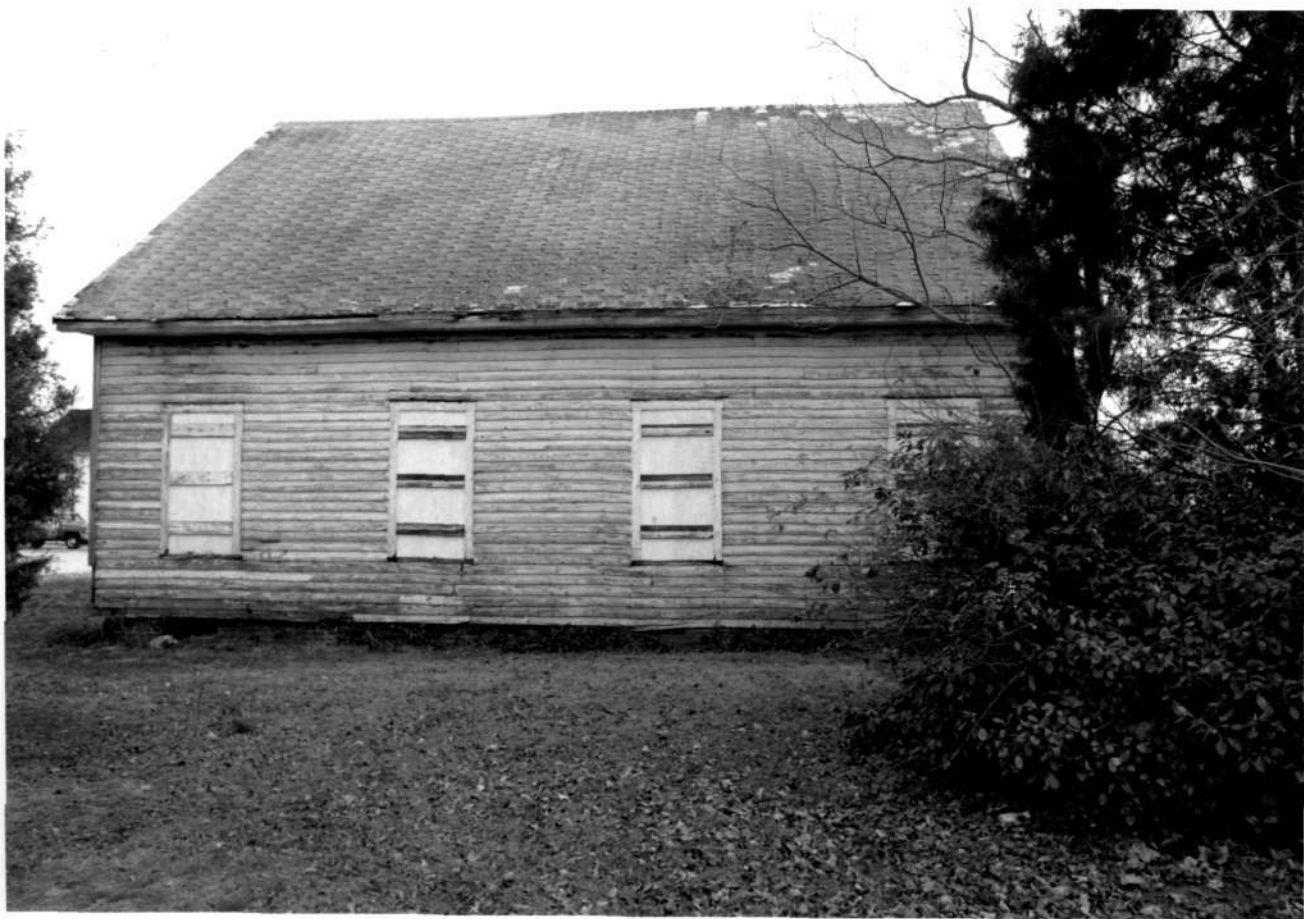
Denton Shirt Factory
CAR-357
Nov. 2002
2 of 5

Description Photograph #4- West elevation view of W. Denton Sewing Factory. Photo taken from the west facing east from adjacent lot.

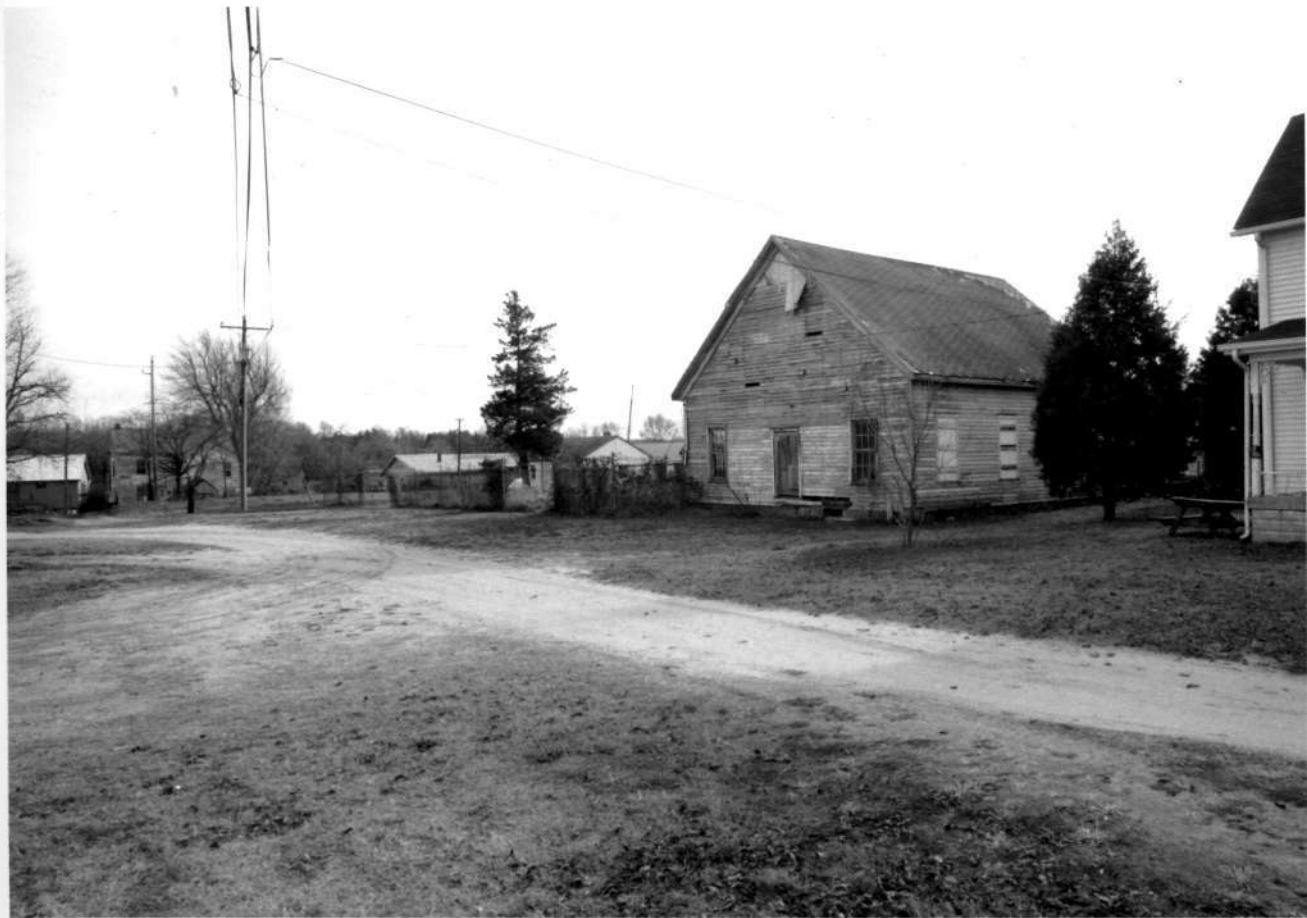
3 of 5

Description Photograph #2- North elevation view of W. Denton Sewing Factory with partial west elevation. Photo take from the northwest facing southeast (towards Choptank River) from Steamboat Alley (unpaved public road).

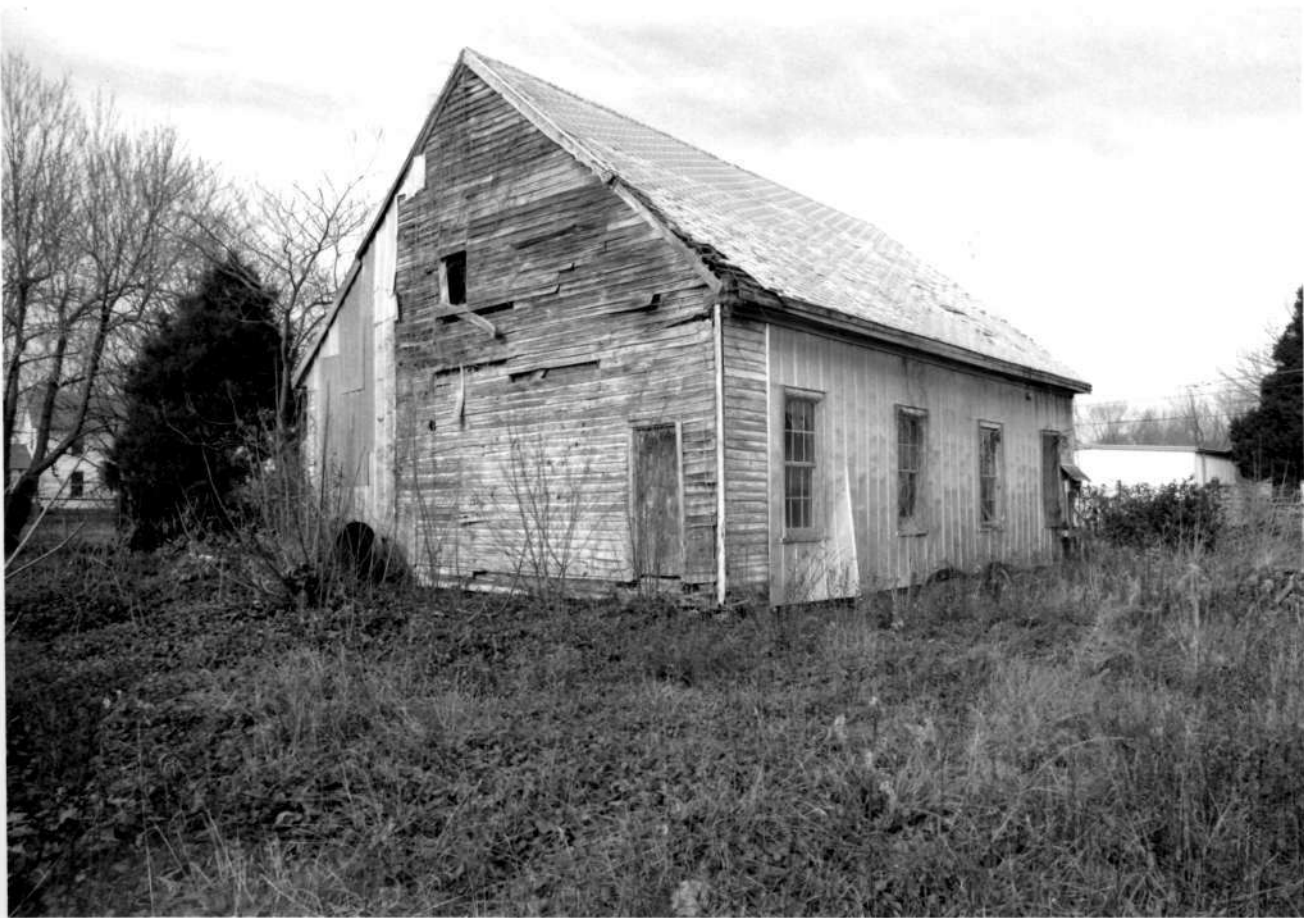
Denton Shirt Factory
CAR-357
Nov. 2002
4 of 5

Description Photograph #5- South elevation view of W. Denton Sewing Factory. Photo taken from the southeast facing northwest from Factory Lane (unpaved public road).

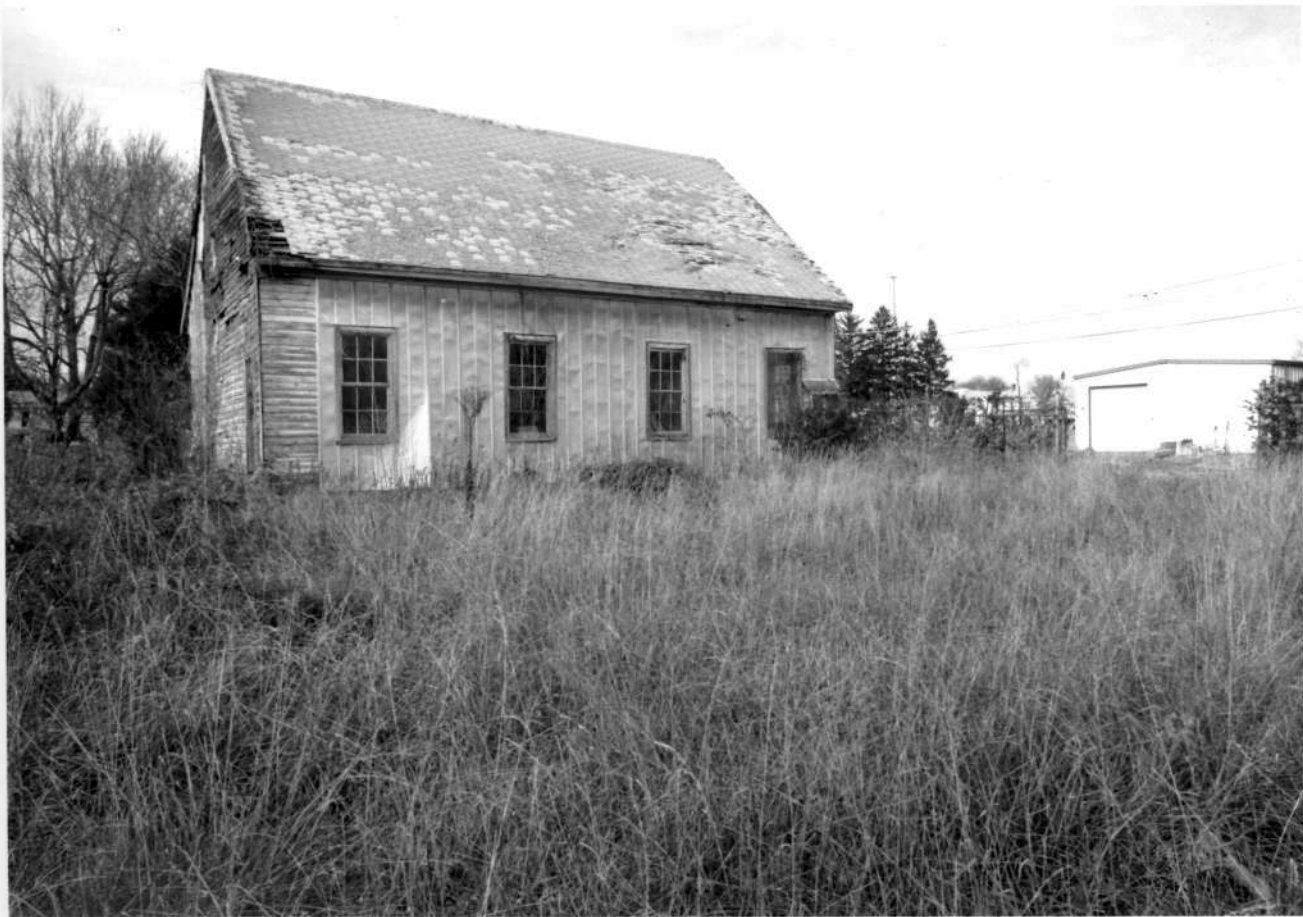
Denton Shirt Factory
Nov, 2002
5 of 5

Description Photograph #3- East elevation view of W. Denton Sewing Factory with partial south elevation. Photo take from the east facing west from Factory Lane (unpaved public road).
